## **IN-SITU METALLOGRAPHY FOR THE PLANT HEALTH ASSESSMENT STUDY AND FAILURE INVESTIGATION**

Virendra K. Bafna and Paresh U. Haribhakti  
TCR Engineering Services Pvt. Ltd.  
Mumbai, India

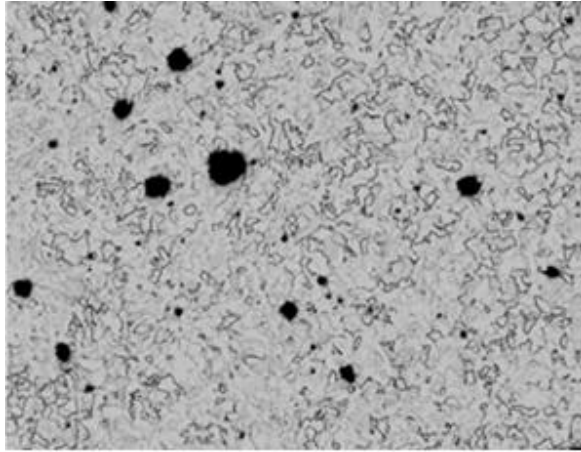
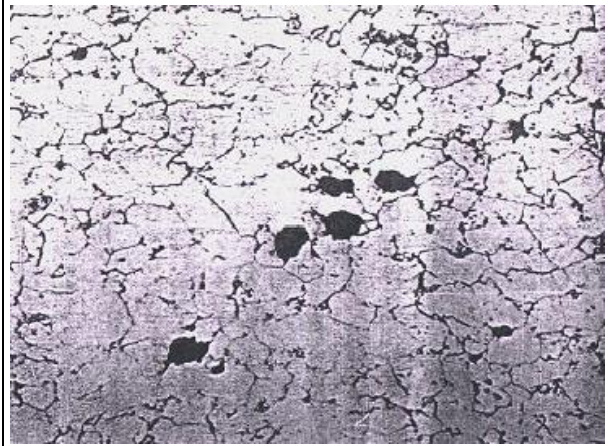
Photo:3 ( 100X)

Graphitization can take place in ferritic steels after exposure to high temperature beyond 400° C for extended time, owing to reversion the cementite in pearlite to a more stable graphite phase. It is a particular form of microstructural degradation that was normally observed frequently in petrochemical components. The mechanical strength is greatly reduced. Steel embrittlement takes place when graphite particles and nodules are formed. The graphitization can take place at the low temperature edge of weld heat affected Zone (HAZ) resulting in a row or band of aligned graphite nodules that may extend across the wall thickness and parallel to weld seam. This form of graphitization can result in significant reduction in loads bearing capacity and thus increase the potential for brittle fracture along this plane.

Photo. 3 and 4 indicates graphite formation in plain carbon steel after a prolonged exposure to high temperature under microstructure..

Photo: 3 and 4 indicates graphite formation in plain carbon steel after a prolong exposure to high temperature.

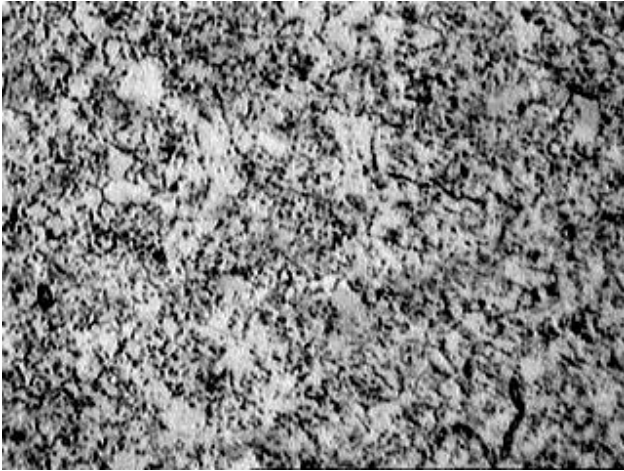
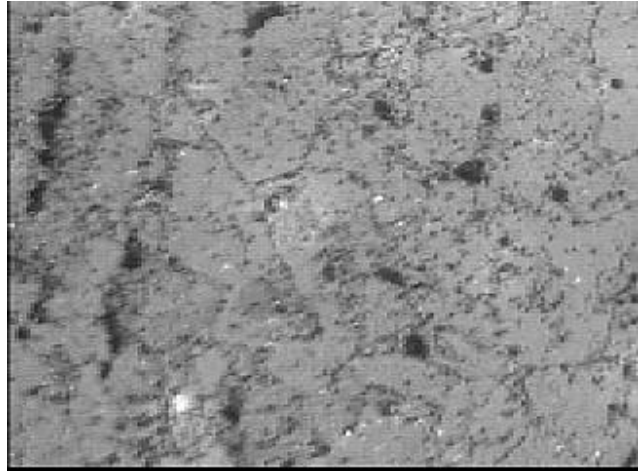
Photo:5

Prolonged high temperature exposure of carbon and low- alloy steels renders pearlite colonies into spheroids. However, addition of alloying elements like Chromium and Molybdenum retards spheroidization. Photo. 5 & 6 shows globular pearlite due to high temperature exposure of steel material for prolonged use. The spheroidization of pearlite reduces the mechanical strength of the steel and alloys steels. When complete spheroidization occurs it needs replacement of the component,

Photo: 5 and 6, Spheroidization of pearlite is observed – the upper microstructure shows in situ spheroidization where as lower structure shows complete spheroidization.

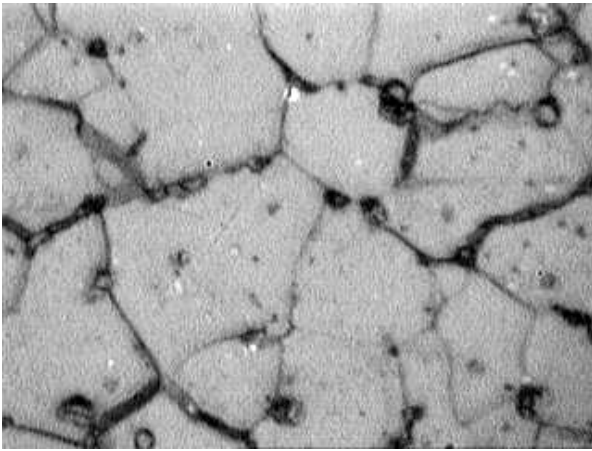
Classification of creep damage in the components exposed to creep range has been made using the largely qualitative approach based on distribution of creep voids and micro cracks observed by in situ metallography. The three stages of creep and associated microstructure degradations are represented in sketch: 3. Basic guidelines for evaluation of creep damage and provide judgment on the inspection intervals are given in Table 1. Photo: 7 & 8 are the optical and SEM micro-photograph of Cr-Mo steel material exposed different creep levels.

Photo. 7 creep voids and micro cracks observed by in situ metallographs under optical microscope. Photo. 8 shows SEM view of replicated microstructure of Cr-Mo steel showing clear presence of oriented creep cavities and micro cracks.

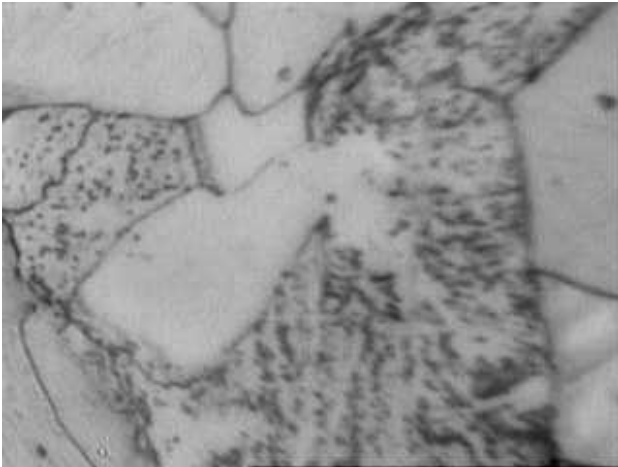
Photo.9

Hydrogen damage, arising particularly in petrochemical industries, can occur in carbon steels through diffusion of atomic hydrogen into the metal, where it combines with carbon in  $\text{Fe}_3\text{C}$  to form Methane and to eliminate pearlite constituent. This is a special case of microstructural degradation. It is less common today than in past because of the use of low alloy steels containing elements that stabilize carbides. Photo: 9 shows carbon steel in which carbides from the original pearlite have been converted to methane producing voids and loss of carbon from the microstructure. Photo: 10 shows complete cracking of steel microstructure due to methane formation and decarburization. Often recrystallization of ferrite takes place around some of the voids that is produced by combination of deformation under pressure of methane and elevated temperature.

Photo. 9 carbon steel in which carbides from the original pearlite has been converted to methane producing voids. Photo. 10 shows complete cracking due to methane formation of use of C-1/2Mo steel material under hydrogram service at elevated temperature.

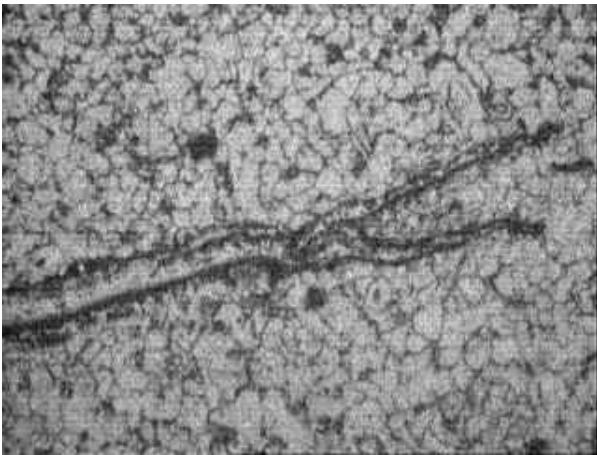
Photo: 11 crack initiation In chrome moly ferritic steel due to thermal fatigue of a tube at the entrance of outlet header of secondary superheater boiler operating at 540°

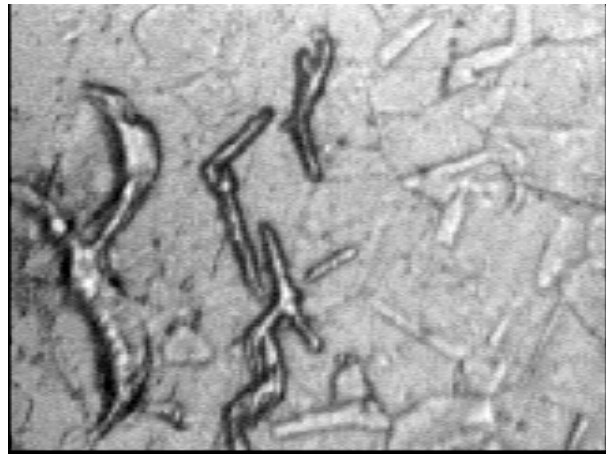
Fatigue, involving repeated stresses, can lead to failure at high temperatures as it does at low temperatures. In components operating at high temperatures it often arises through temperature changes that can lead to cyclic thermal stresses. Eventually thermal fatigue cracking would take place in the areas where temperature fluctuation and variations are more. The nature of cracks are trans-granular in nature. Photo: 11 shows crack formation in chrome moly ferritic steel due to thermal fatigue of a tube at the entrance of outlet header of secondary superheater boiler operating at  $540^\circ\text{C}$ . Photo: 12 shows development of thermal fatigue crack with SS 316 at the steam inlet of paper digester.

Photo: 12 shows development of thermal fatigue crack with SS 316 at the steam inlet of paper digester.

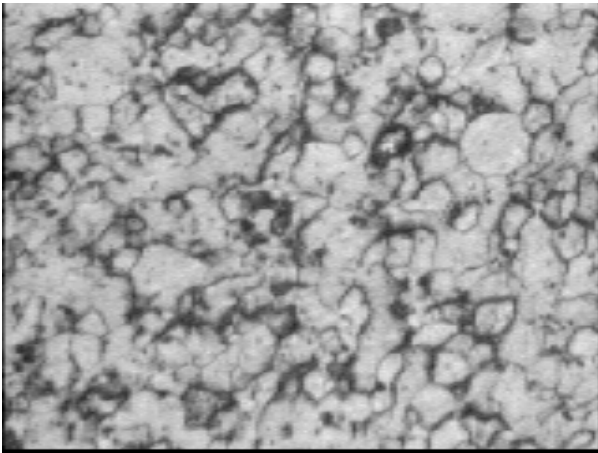
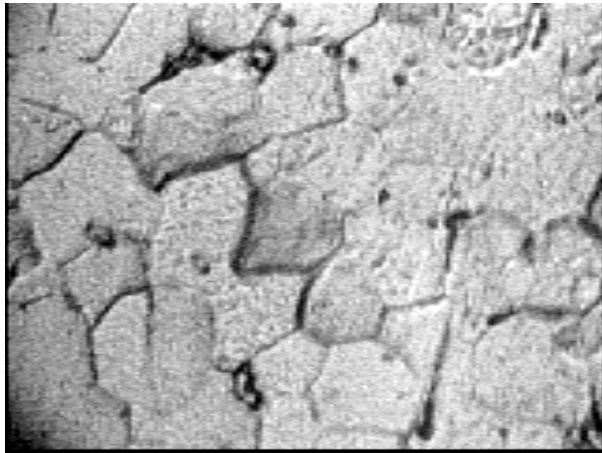
Photo:13

Under highly oxidizing atmosphere grain boundary oxidation takes place that penetrates inside. Thus, the thickening of grain boundaries in carbon steels can be seen with etching response in situ metallography. Photo: 13 and 14 shows grain boundary oxidation damage on plain carbon steel surface, necessitating replacement of the component.

Photo: 13& 14 shows plain carbon steel of a cement kiln shell. The temperature rise occurred due to breakage of internal refractory and external surface got several oxidized.

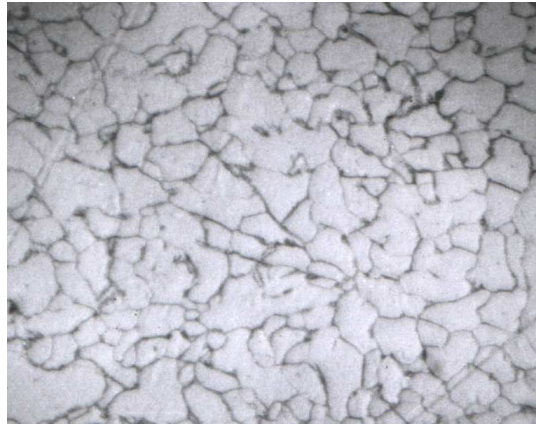
Photo:15

oxidizing atmosphere at high temperature can be identified in microstructure which is shown in photo:15.

Photo. -15 essentially ferritic structure showing removal of carbon form the surface of the steel.

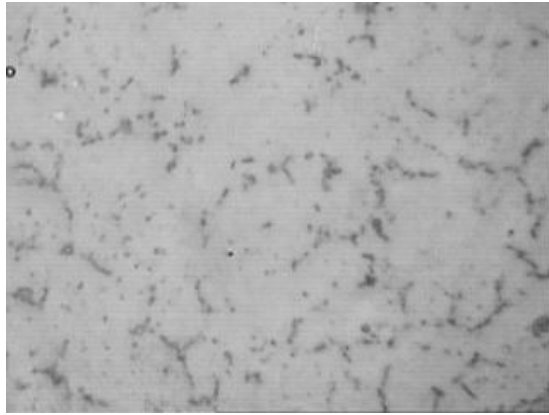
Embrittlement from precipitations arise in a number of different ways for instance, sigma phase formation in austenitic stainless steels maintained at high temperature or cycled through the critical temperature range of 565 to 989 ° C causes loss of ductility and embrittlement. Ferritic stainless steels may be subjected to embrittlement phenomenon when held at or cooled over the temperature range 550 to 400 °C. If the temperature conditions are likely to lead to such effects, metallographic checks are employed after extended exposure prior to an unexpected rupture developing. Photo: 16 grain boundary sigma formation of SS 316 stainless steel tubes used in the high temperature service.

Photo: 16 Sigma phase formation of SS 316 material operating at 600°C temperature for long time.
